# **Red Cedar Professional Inspections**

# April 28th 2023, 11:00 am

BUILDING ADDRESS: XXX Josie Ln

CITY: Clarksville

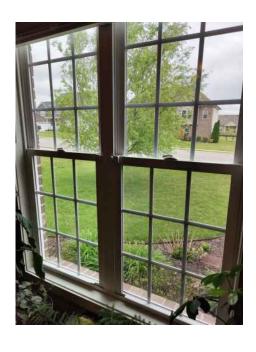
Left side of window frame on bottom left is damaged. Possible chew marks from pet. Seal is damaged. Recommend evaluation by qualified contractor.
